**Post blast investigation:
15/ 04/ 14
Shot PG 7 (AT Rocket) against EOD ambulance 2619**

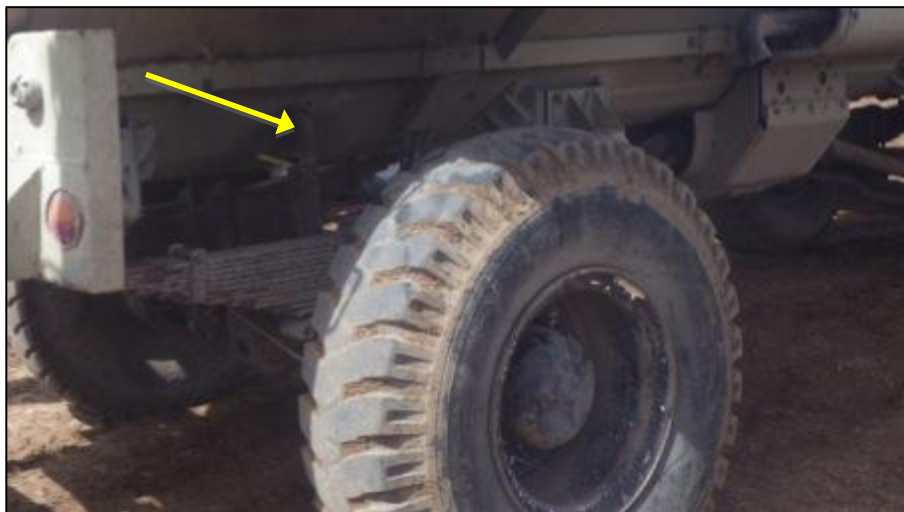
On 15/04 /14, approximately 1500 m after the team left FOB Beled Amin, en route to FOB Qoryoley, just after the first bridge (N 01° 44' 08.9 E 044° 36' 47.0), the EOD ambulance was shot by a PG7 rocket.

The impact is located at the upper side of the right rear wheel.

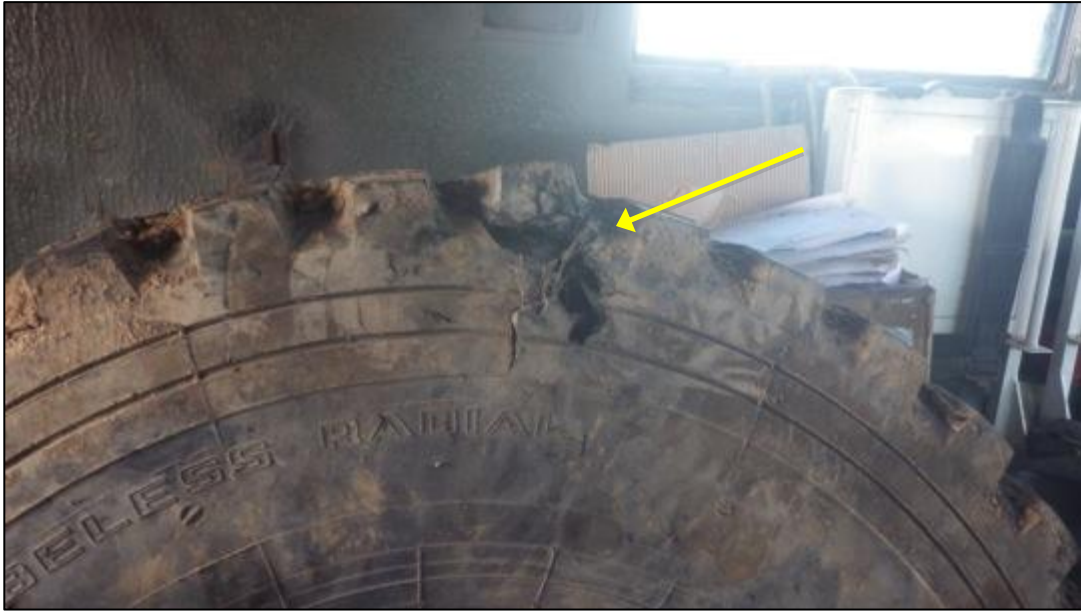
Trajectory of the rocket on the target:

The shape charge has perforated the wheel, in first

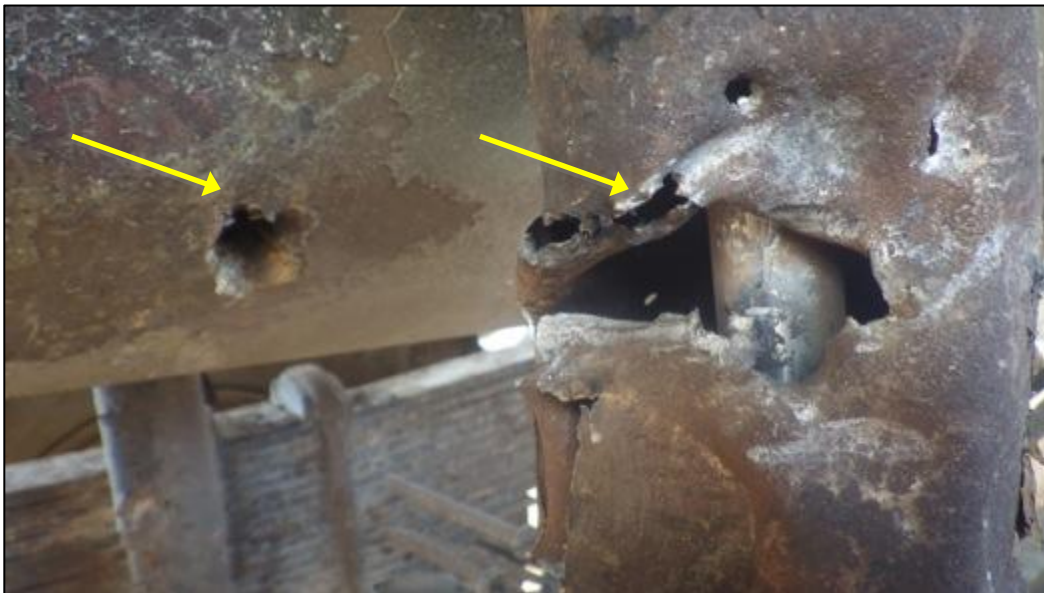
The shock absorbers, in second and the coachwork in third

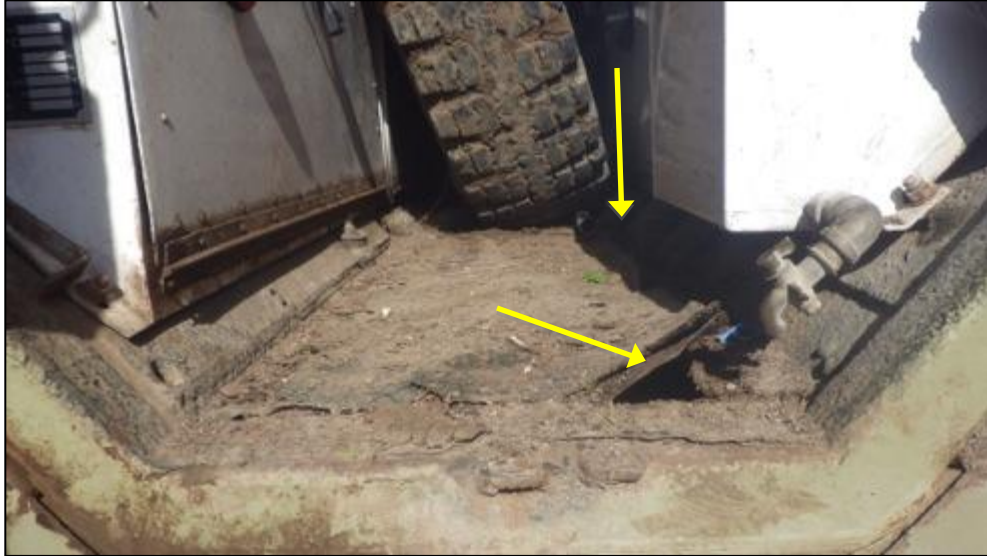
Inside the Casspir, the impact is located under the floor. The pressure has deformed the floor but no fragmentation entered the life cell.

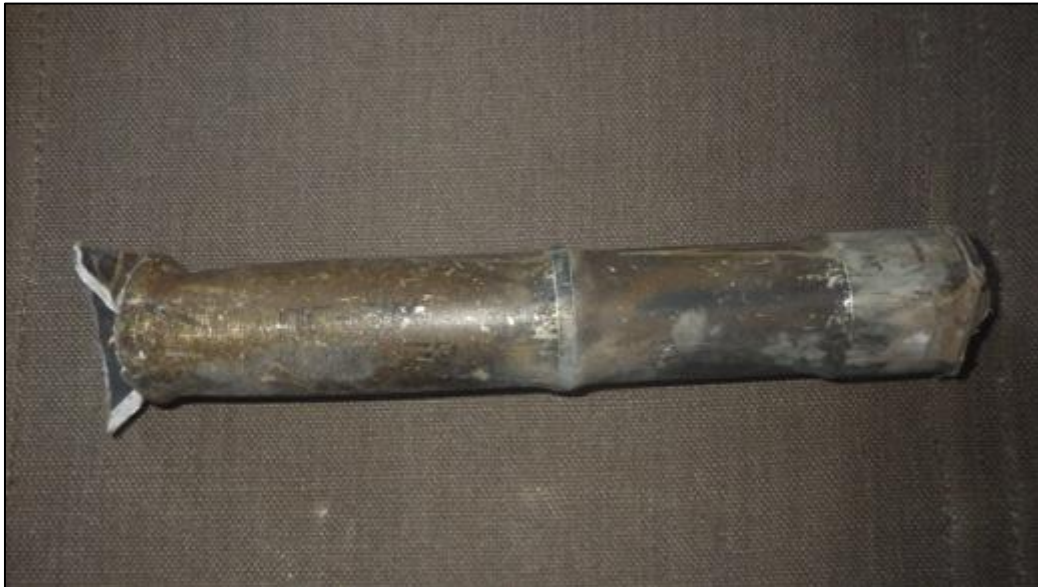
Propulsion found after the shot

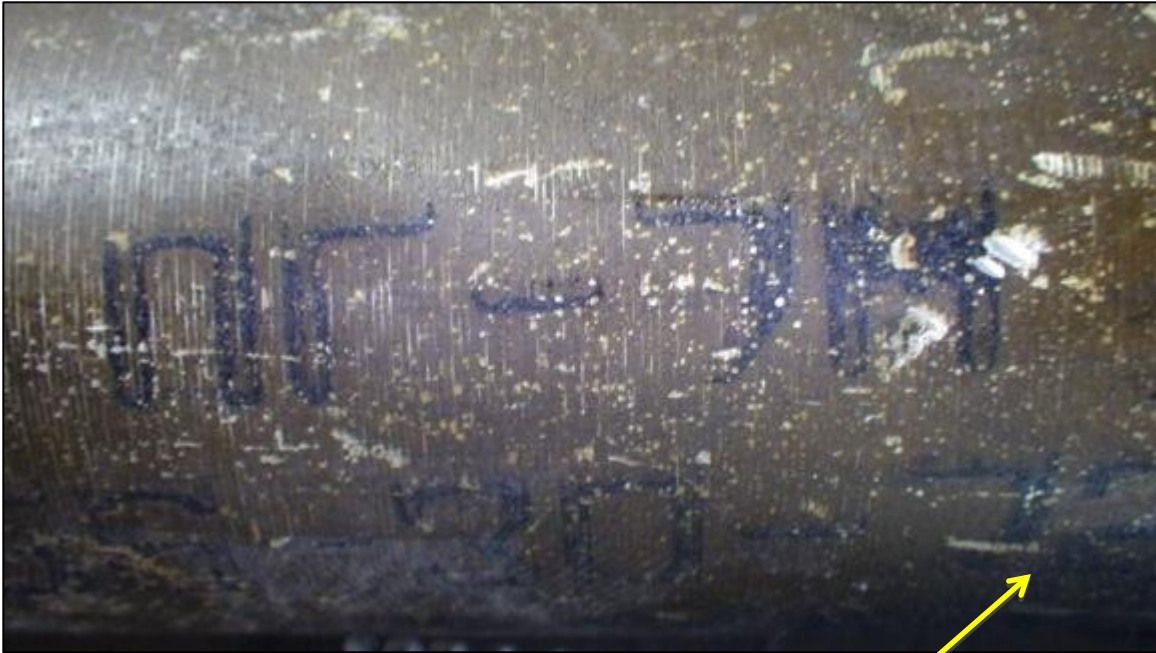
Rocket Anti tank PG7M (Bulgarie)

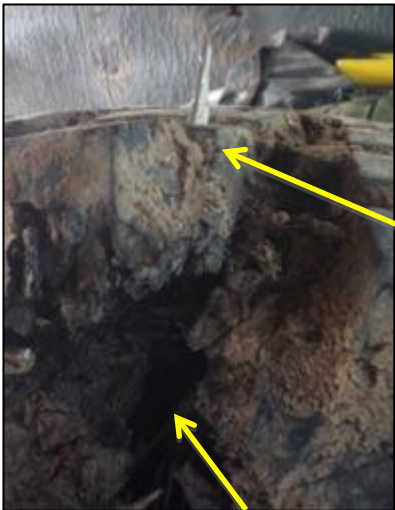
Wheel impact

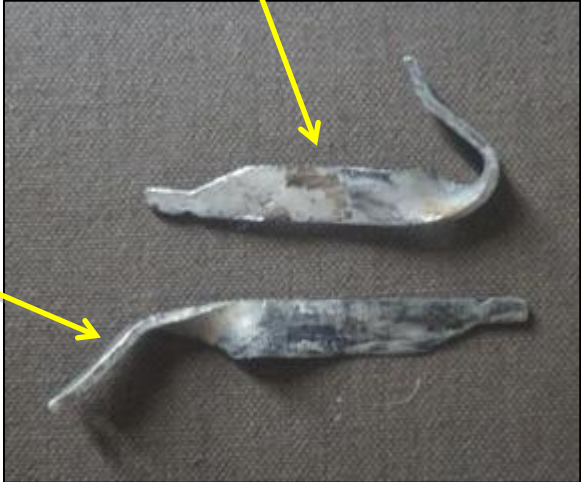
Stability wing
